# Flush Valve Installation And Problem Solving

# Close Coupled Cistern & Flush Level or Button Installation

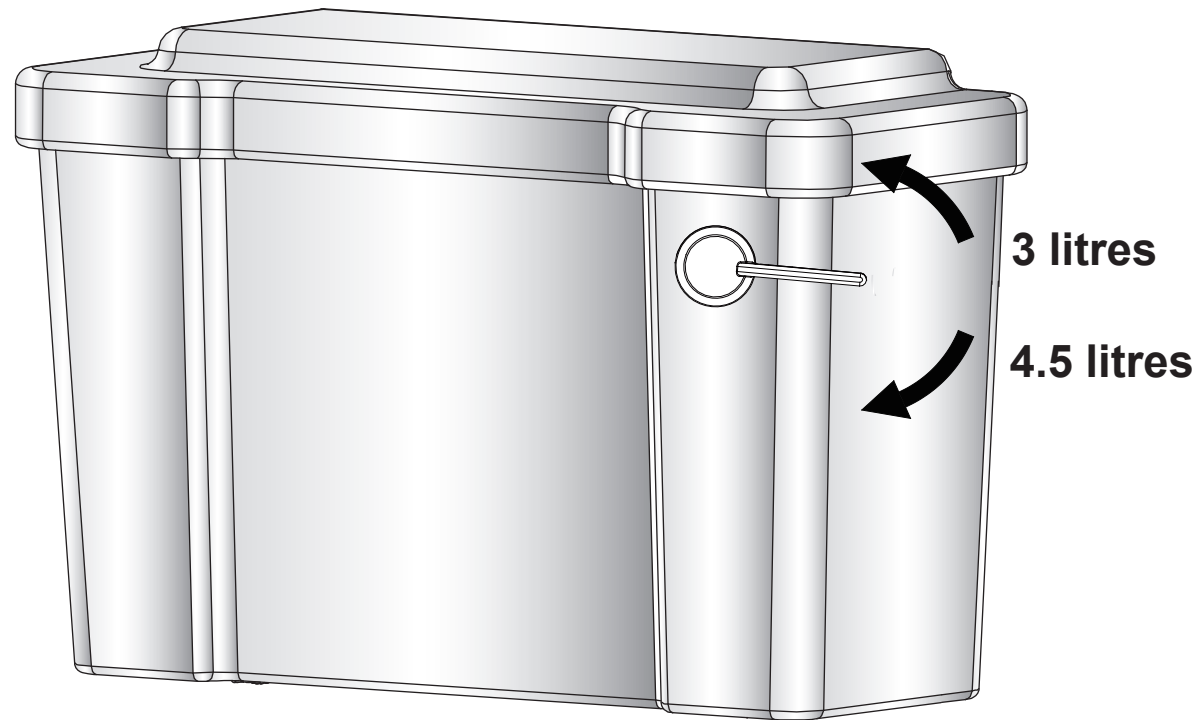
All WC's come with a 3/4.5 litre flush as standard. For lever flush cistern fittings, you must press the lever down lightly for the 4.5 litre flush and lightly lift the lever for the 3 litre flush.

Please note that it is imperative that there are no loops or kinks in the yellow tube when installed and that the lever is not operated with excessive force as this will damage the cable inside the tube that lifts and lowers the flush valve causing the flush to fail beyond repair

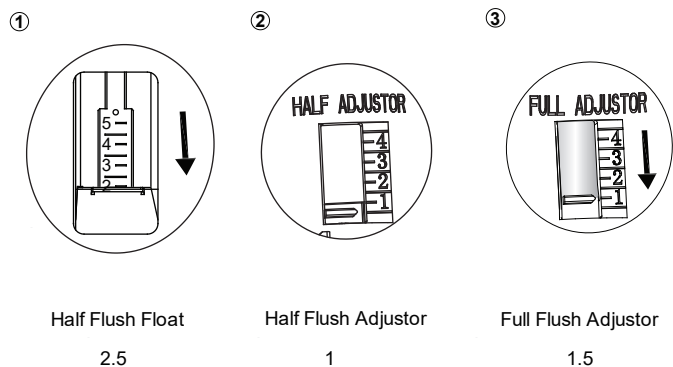
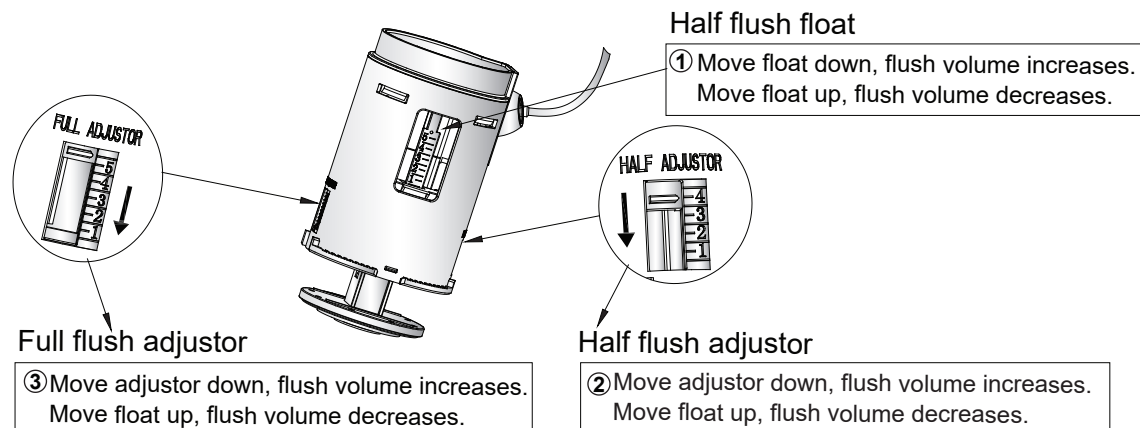
## 1: Flush Valve scale and adjustment setting

**Note:** The below diagram ① is set to 2.5, ② is set to 1, and ③ is set to 1.5.  
For adjustment method, please refer to the adjustment setting on right side.

Problem	Reason	Solution
Leakage	1. Incorrect installation. 2. Flush valve seat does not fit flush valve body. 3. Flush valve body is stuck.	1. Install again according to the correct installation procedure. 2. Install again. 3. Disconnect and wash flush valve body.
No flush, low flush or half flush volume	Cable is distorted.	Remove kinks or sharp bends in the cable.
Half flush water level is too high or too low.	Water level is adjusted incorrectly.	Adjust water level.
